**PEUGEOT 5008: 2BHF711**

**Limited Technical Inspection**

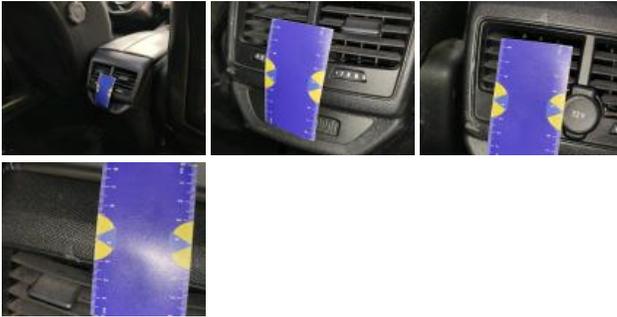
Centre console, Scratch(es), Smart repair
