## HYUNDAI Nexo: CDBA341

| Vinnumber: | KMHJ8816FLY008830 | Versionname: | Nexo FCEV 1 (Hydrogen) 120kW/163pk 5D/P Auto-1 |

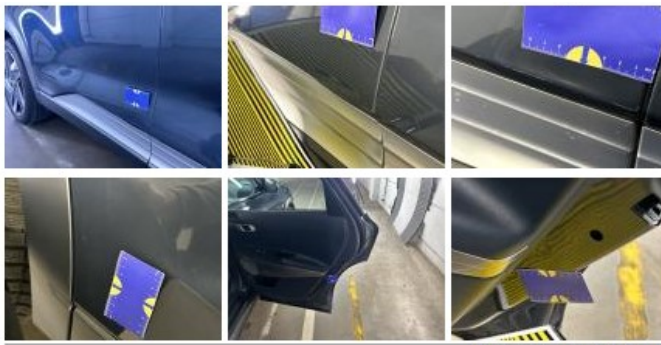
Door RR, Dent(s) and scratch(es), Spot repair
