## HYUNDAI Kona: 1YPY092

| Vinnnumber: | <b>KMHK581GFLU086972</b> | Versionname: | <b>Kona Electric Sky 64kWh 150kW/204pk 5D/P Auto-1</b> |

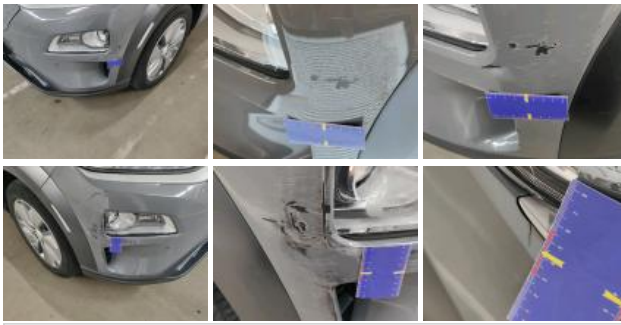
Bumper F, Crack, Replace and paint

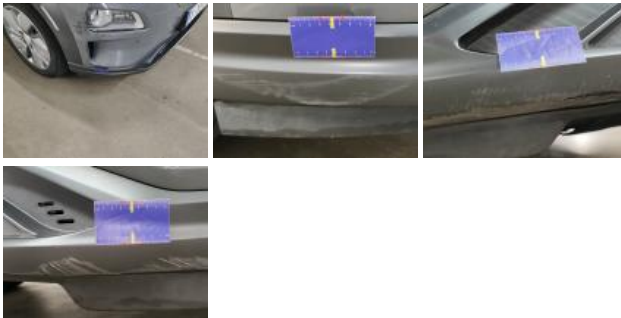
Bumper spoiler F, Scratch(es), Replace
