| HYUNDAI Nexo: CDBA332 | | | | |
| Vinnnumber: | KMHJ8816FLU008829 | Versionname: | Nexo FCEV 1 (Hydrogen) 120kW/163pk 5D/P Auto-1 | |

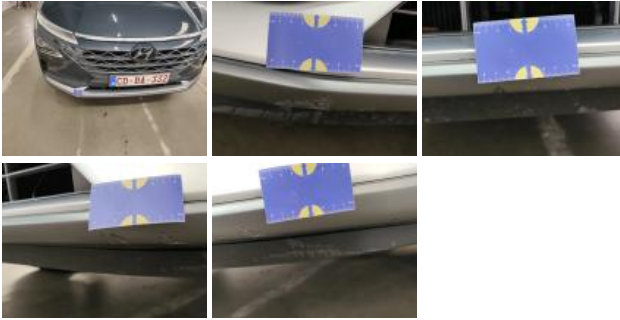
Bumper spoiler F, Scratch(es), Smart repair
