**PEUGEOT 508 SW: 2ACT548**

Vinnumber:	<b>VR3FCYHZTY051610</b>	Versionname:	<b>508 SW 1.5 BlueHDi 130 S/S EAT8 Allure Pack</b>
First Registrationdate:	<b>22/02/2021</b>	Fiscalpower:	<b>96kW/130pk 5D/P Auto-8</b>
Expertise Mileage:	<b>40313</b>	Power Kw:	
Bodytype:		Body colour:	<b>Blue</b>
Gearbox:	<b>Automatic</b>	Type of rims (mounted):	<b>Aluminium</b>
Transmission:	<b>Front</b>	Parking lot:	<b>pp64</b>
Fueltype:	<b>Diesel</b>		
Number of doors:	<b>5</b>		
Number of seats:	<b>5</b>		
Number head rests:	<b>5</b>		
Type of rims (mounted):	<b>Aluminium</b>		
Certificate of Conformity:	<b>Yes</b>		
Category:	<b>Passenger Car</b>		
Registration Certificate Car (BE):	<b>Yes</b>		
Bodywork:	<b>Clean</b>		
Interior:	<b>Clean</b>

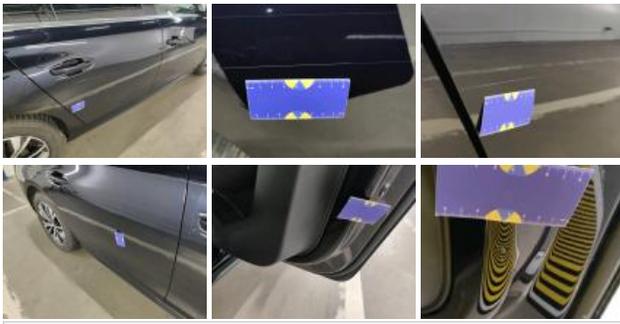
Door RR, Dent(s) and scratch(es), Repair and paint (complete)
