MACADAM

HYUNDAI Nexo: CDBA388

Limited Technical Inspection

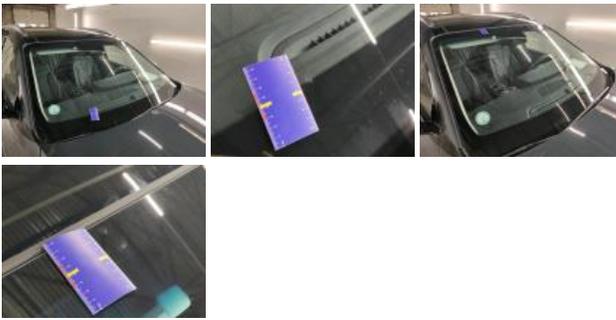
Windscreen, Stone chip(s), Acceptable
