PEUGEOT 2008: 2CMX323

Limited Technical Inspection

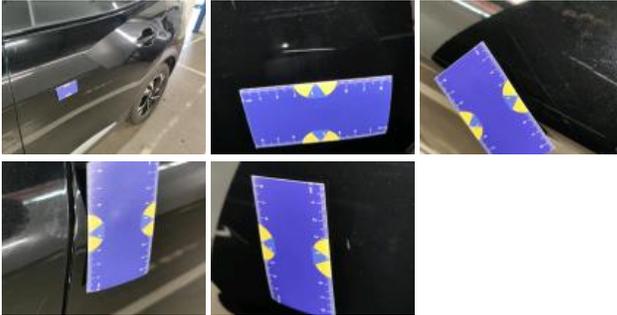
Step L, Dent(s) and scratch(es), Spot repair
