MACADAM

MERCEDES Vito: 1YQV457

Vinnnumber:	W1V44770313788309	Versionname:	Vito 116 CDI Mixto Perfect Tool L2 120kW/163pk
First Registrationdate:	10/11/2020	Fiscalpower:	5D/P Auto-9
Expertise Mileage:	236216	Power Kw:	
Bodytype:		Body colour:	Black
Gearbox:	Automatic	Type of rims (mounted):	Steel
Transmission:	Back	Parking lot:	d040
Fueltype:	Diesel		
Number of doors:	4		
Number of seats:	5		
Number head rests:	5		
Type of rims (mounted):	Steel		
Certificate of Conformity:	Yes		
Category:	Light Commercial Vehicle		
Registration Certificate Car (BE):	Yes		
Bodywork:	Clean		
Interior:	Dirty

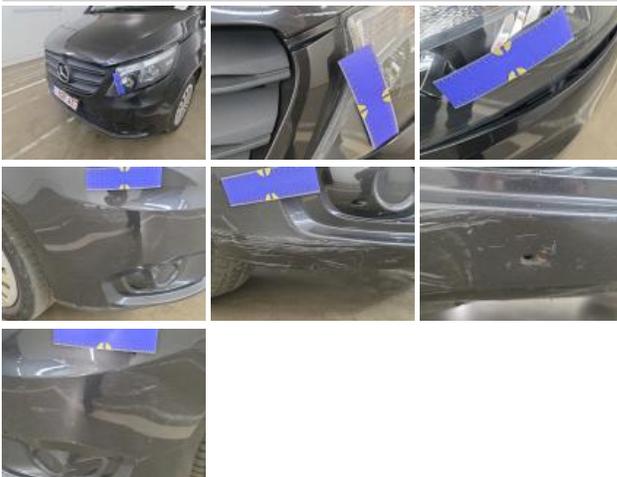
Bumper F, Crack, Replace and paint

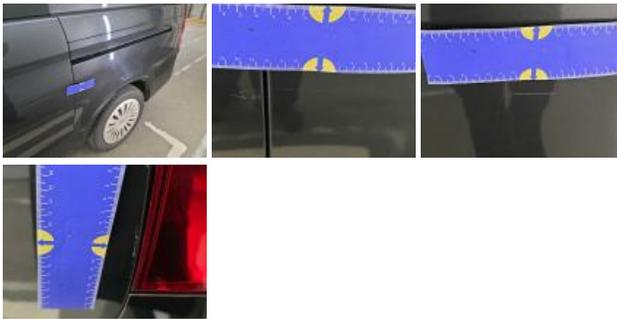
Wing RL, Scratch(es), Acceptable

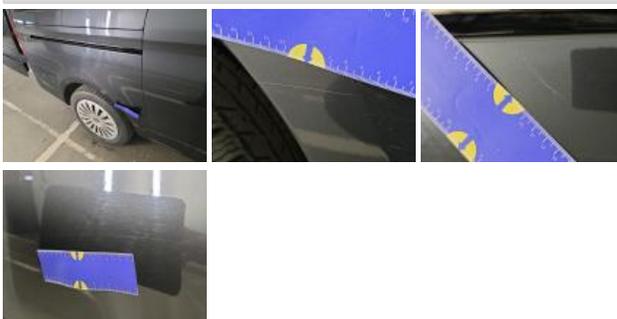
Wing RR, Scratch(es), Repair and paint (complete)

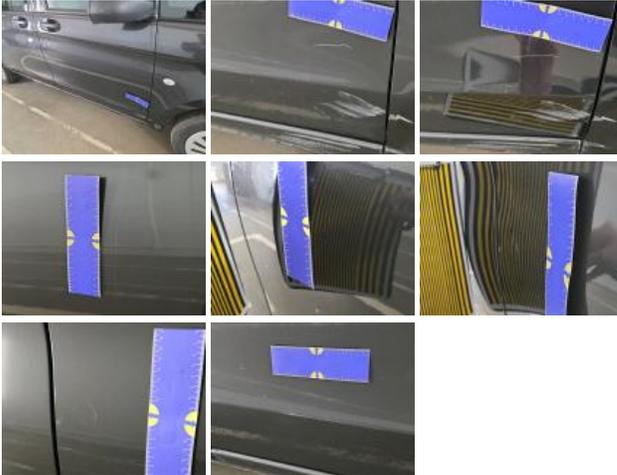
Door FR, Dent(s) and scratch(es), Repair and paint (complete)

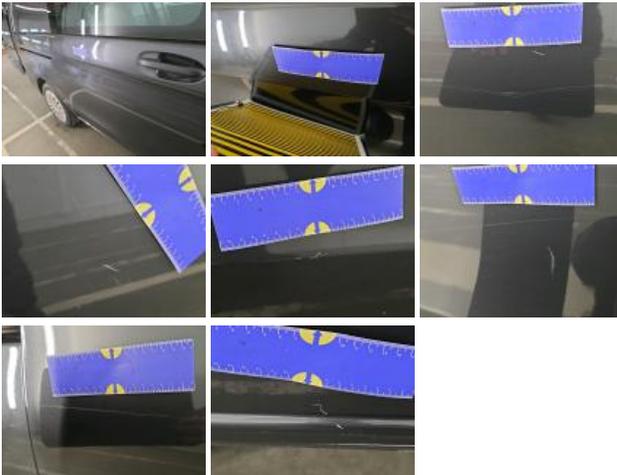
Door RR, Dent(s) and scratch(es), Repair and paint (complete)

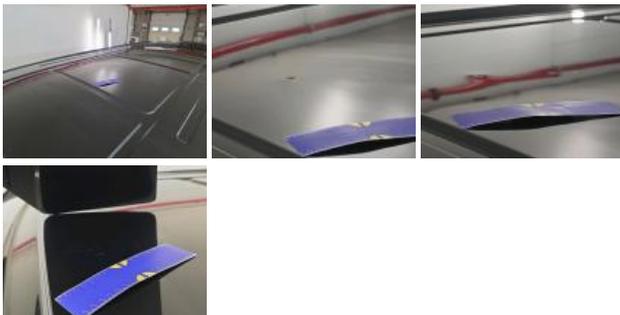
Roof, Dent(s), Paintless dent repair

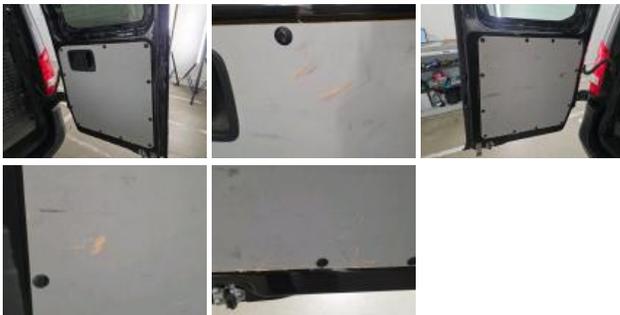
Bodywork, Scratch(es), Acceptable
