PEUGEOT 3008: 2BFH857

Limited Technical Inspection

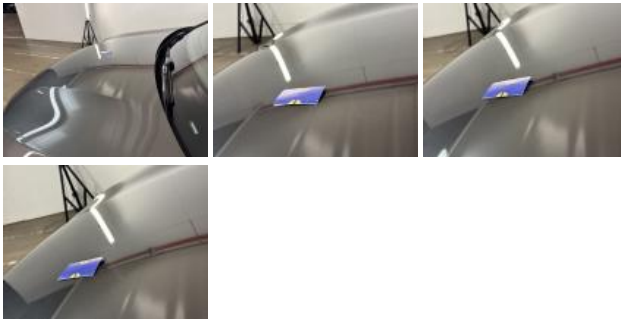
## Bonnet, Scratch(es), Polish

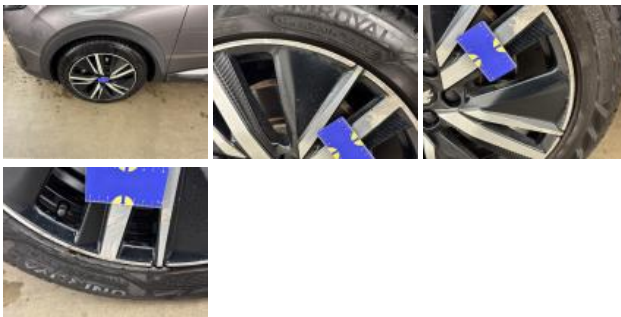
## Alloy rim FL polished, Scratch(es), Repair and paint (complete)

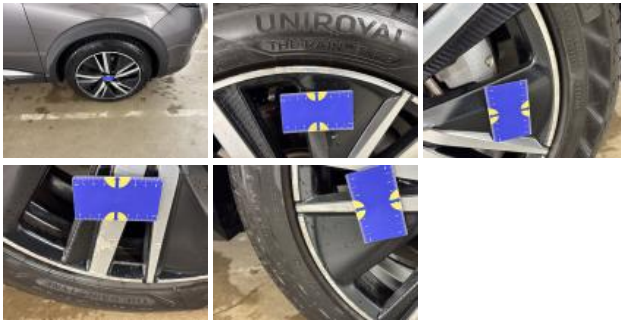
Alloy rim FR polished, Scratch(es), Repair and paint (complete)

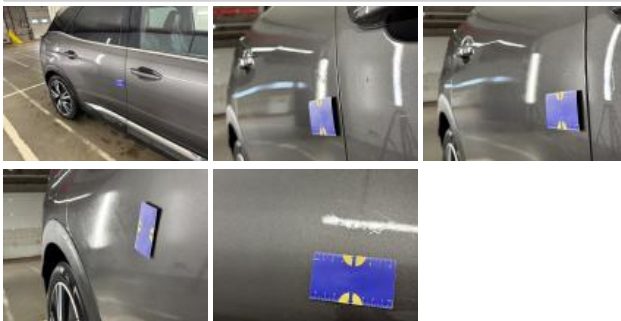
Door RR, Bad repair, Repair and paint (complete)

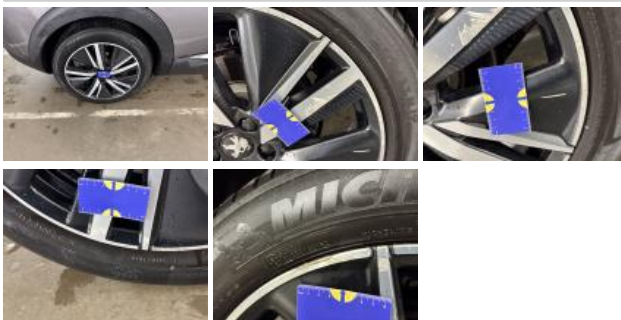
Alloy rim RR polished, Scratch(es), Repair and paint (complete)
