## SKODA Enyaq: 2AVQ257

| Vinnumber: | <b>TMBJB7NY3NF010029</b> | Versionname: | <b>Enyaq iV 60 132kW/180pk 5D/P Auto-1</b> |

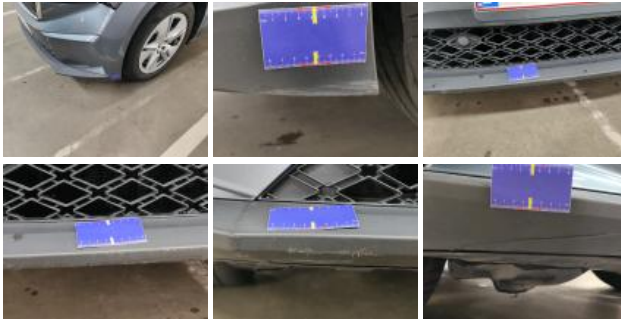
Bumper F, Crack, Replace and paint

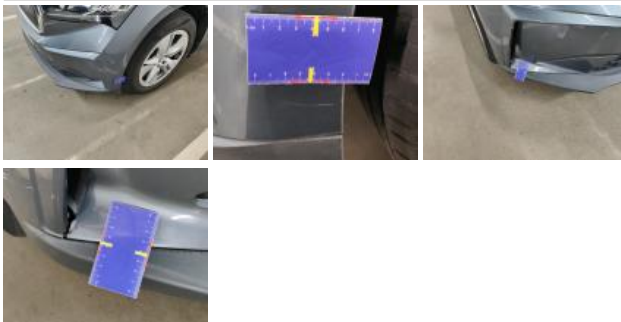
Headlight L, Crack, Replace
