PEUGEOT 208: 2BMX808

Limited Technical Inspection

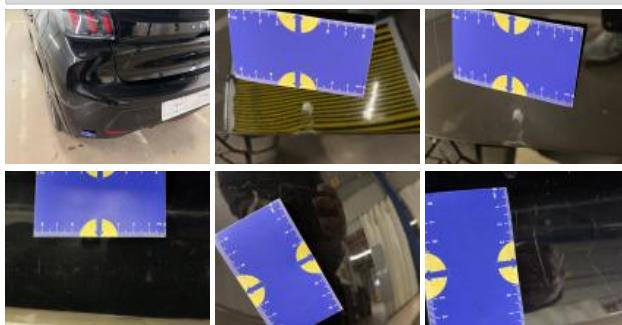
Bumper R, Dent(s) and scratch(es), Spot repair
