**VOLVO XC60: 2APF357**

| Vinnnumber: | <b>YV1UZK5VDM1846806</b> | Versionname: | <b>XC60 B4 D Geartronic Momentum Pro 145kW/197pk 5D/P Auto-8</b> |
| Expertise Mileage: | <b>152026</b> | Power Kw: | <b>145</b> |

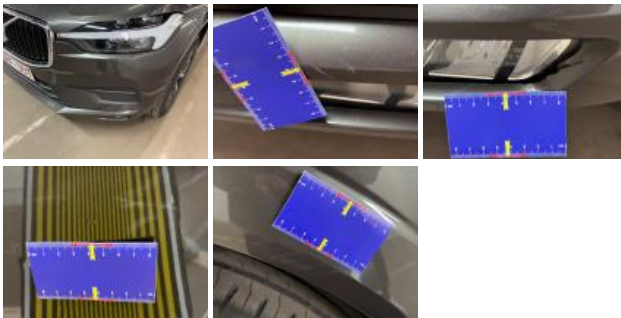
Bumper F, Crack, Replace and paint
