### MERCEDES EQS: CDBB462

Vinnnumber:	<b>W1KCG2DBXPA028687</b>	Versionname:	<b>EQS EQS 450+ Luxury Line 245kW/333pk 5D/P Auto-1</b>
First Registrationdate:	<b>6/01/2023</b>	Fiscalpower:	
Expertise Mileage:	<b>77620</b>	Power Kw:	
Bodytype:		Body colour:	<b>Blue</b>
Gearbox:	<b>Automatic</b>	Type of rims (mounted):	<b>Aluminium</b>
Transmission:	<b>Back</b>	Parking lot:	<b>pp94</b>
Fueltype:	<b>Electric</b>		
Number of doors:	<b>5</b>		
Number of seats:	<b>5</b>		
Number head rests:	<b>5</b>		
Type of rims (mounted):	<b>Aluminium</b>		
Certificate of Conformity:	<b>Yes</b>		
Category:	<b>Passenger Car</b>		
Registration Certificate Car (BE):	<b>Yes</b>		
Bodywork:	<b>Clean</b>		
Interior:	<b>Clean</b>

### Limited Technical Inspection

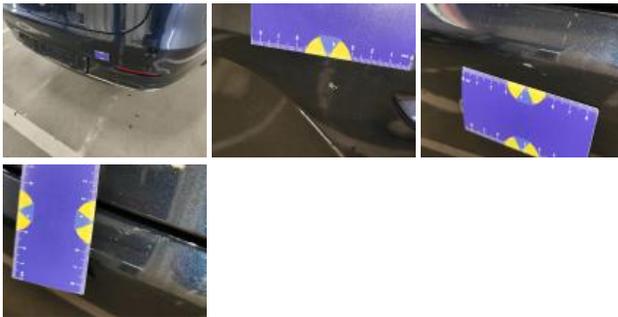
Bumper R, Scratch(es), Acceptable

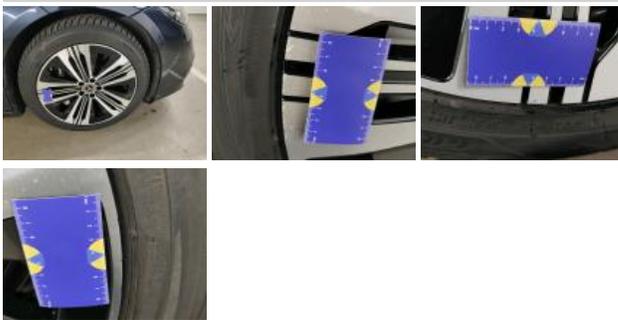
Alloy rim FR polished, Scratch(es), Acceptable
