VOLVO V60: 1XKC867

Limited Technical Inspection

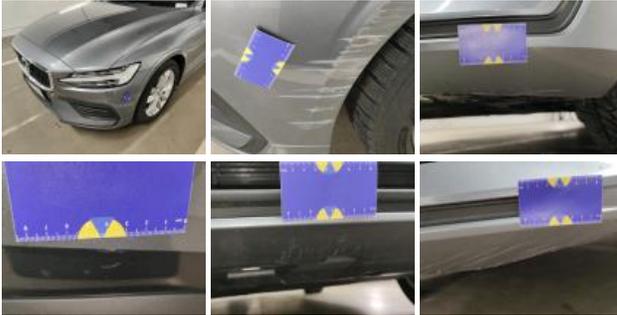
Bumper F, Scratch(es), Repair and paint (complete)

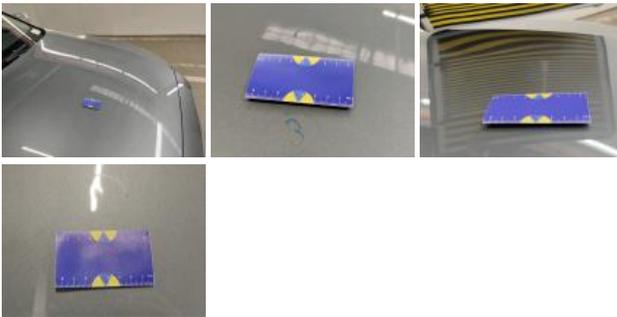
Bonnet, Hail damage, Paintless dent repair (hail)

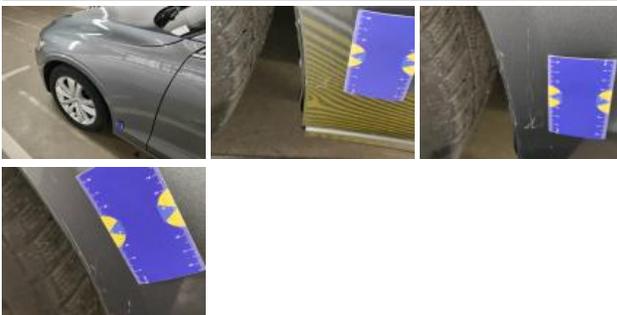
Wing FL, Scratch(es), Spot repair

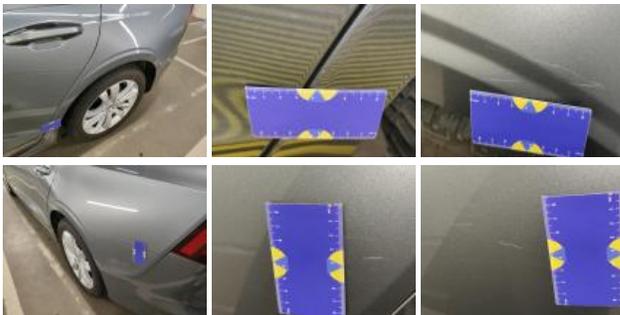
Wing RL, Dent(s), Spot repair

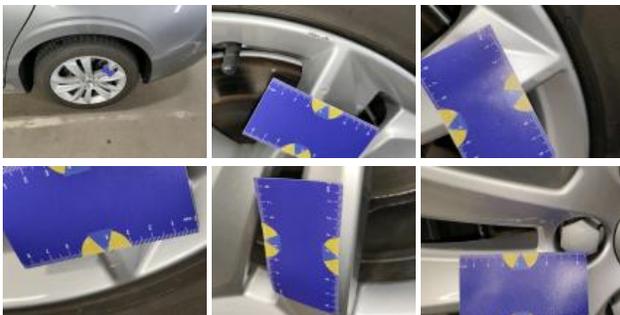
Alloy rim RL, Scratch(es), Repair and paint (complete)

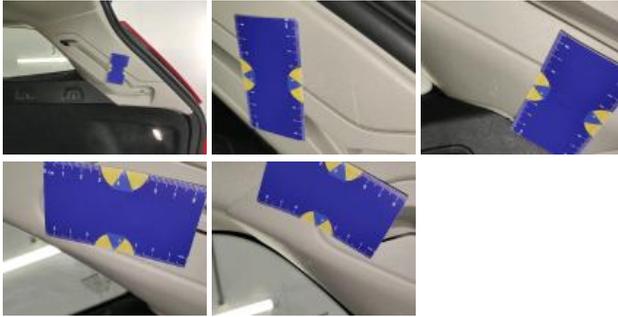
Internal boot lining R, Scratch(es), Smart repair

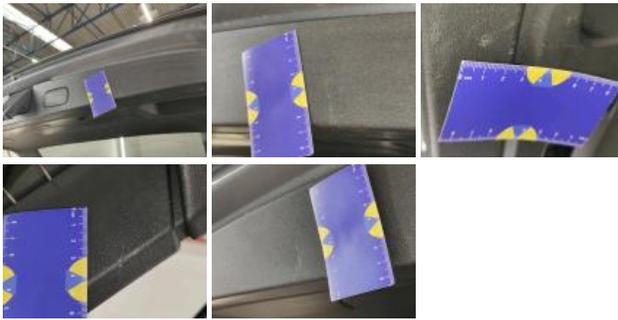
Boot lid covering R, Scratch(es), Smart repair

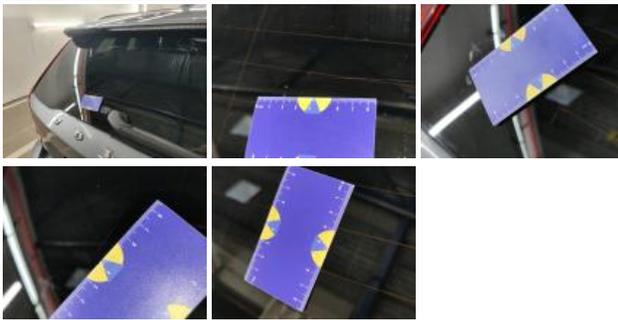
Rear window, Scratch(es), Polish

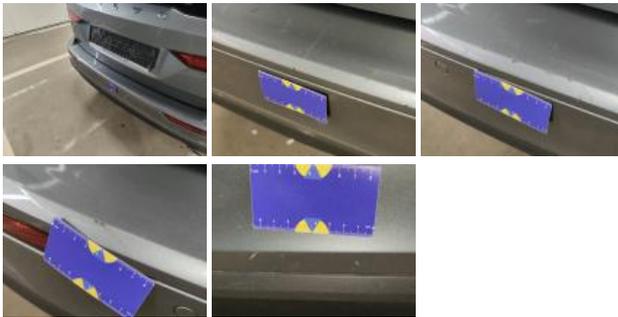
Bumper R, Scratch(es), Repair and paint (complete)

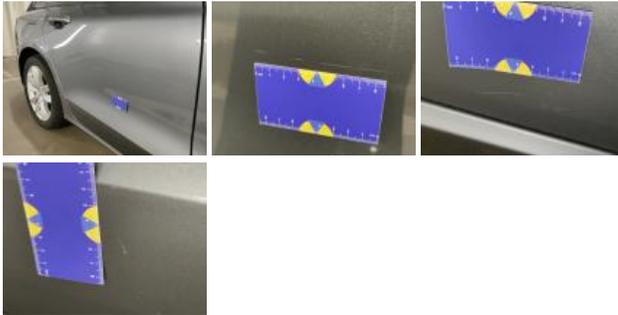
Door RR, Scratch(es), Polish

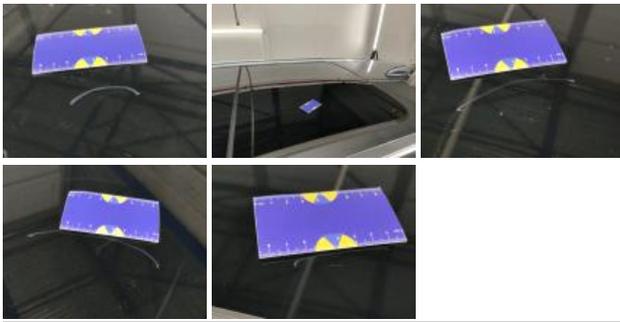
Panoramic roof, Scratch(es), Polish
