| OPEL Grandland: 2CFJ232 | | | |
| Vinnumber: | W0VZRHNS0N6821776 | Versionname: | Grandland 1.2 Turbo S/S AT8 Business Elegance |

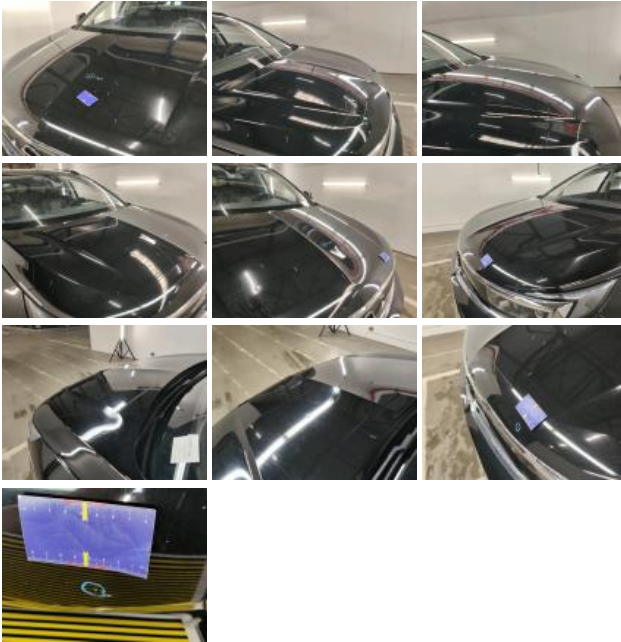
Bonnet, Dent(s) and scratch(es), Repair and paint (complete)

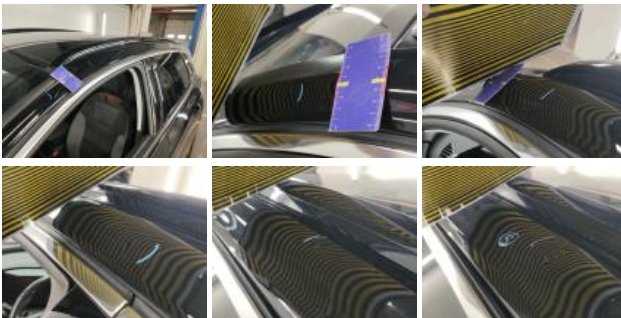
Roof pillar L, Hail damage, Paintless dent repair (hail)

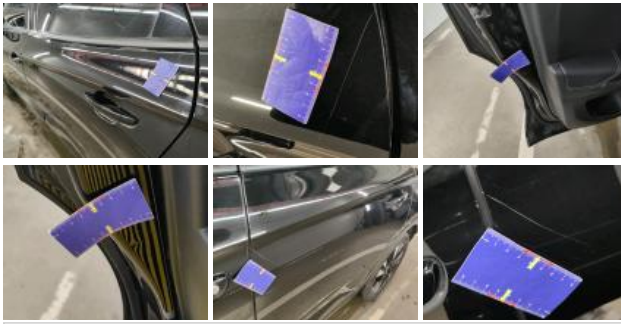
Door RL, Scratch(es), Polish

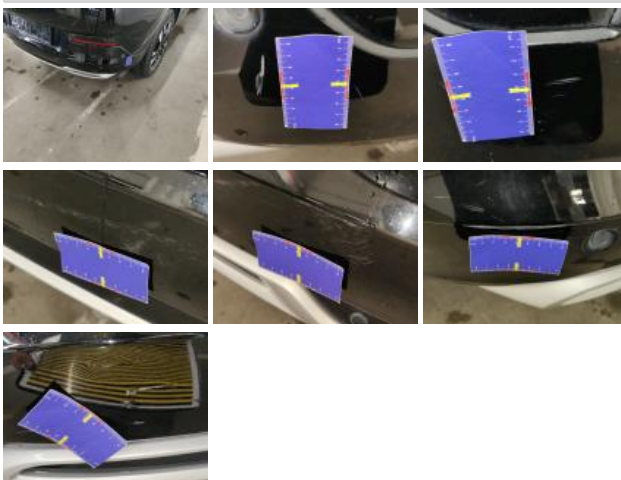
Bumper R, Dent(s) and scratch(es), Repair and paint (complete)

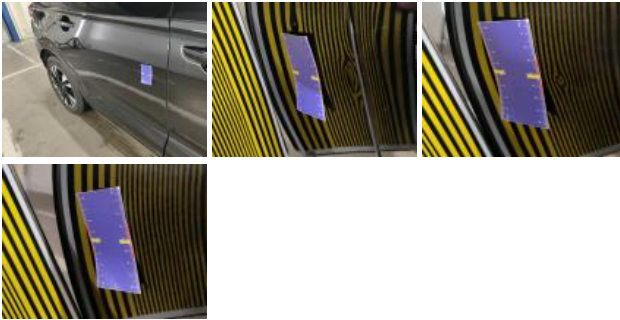
Door RR, Dent(s), Paintless dent repair

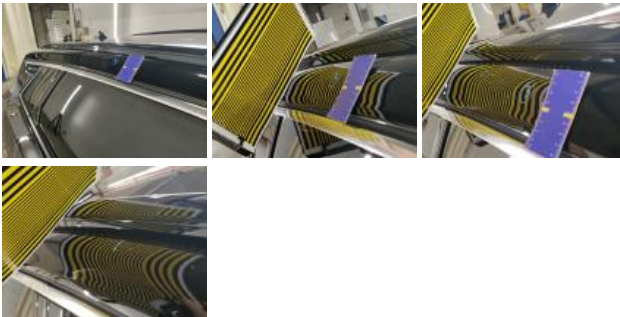
Roof pillar R, Hail damage, Paintless dent repair (hail)

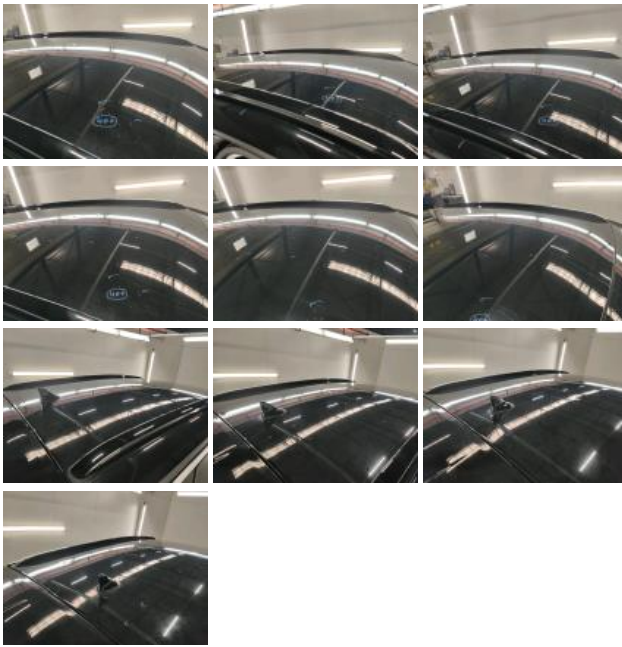
Roof, Hail damage, Repair and paint (complete)
