## SEAT Ateca: 2DHD183

Vinnumber:	<b>VSSZZZ5F6P6542109</b>	Versionname:	<b>Ateca 1.0 TSI Move Navi 81kW/110pk 5D/P Man-6 (4 seizoenen Banden) - CO2 indicatief</b>
First Registrationdate:	<b>17/03/2023</b>	Fiscalpower:	
Expertise Mileage:	<b>65599</b>	Power Kw:	
Bodytype:		Body colour:	<b>Grey</b>
Gearbox:	<b>MAN 6 VIT</b>	Type of rims (mounted):	<b>Aluminium</b>
Transmission:	<b>Front</b>	Parking lot:	<b>pp03</b>
Fueltype:	<b>Petrol</b>		
Number of doors:	<b>5</b>		
Number of seats:	<b>5</b>		
Number head rests:	<b>5</b>		
Type of rims (mounted):	<b>Aluminium</b>		
Certificate of Conformity:	<b>Yes</b>		
Category:	<b>Passenger Car</b>		
Registration Certificate Car (BE):	<b>Yes</b>		
Bodywork:	<b>Clean</b>		
Interior:	<b>Clean</b>

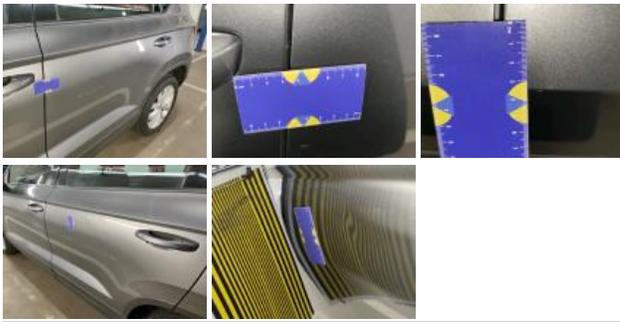
Door RL, Dent(s), Paintless dent repair

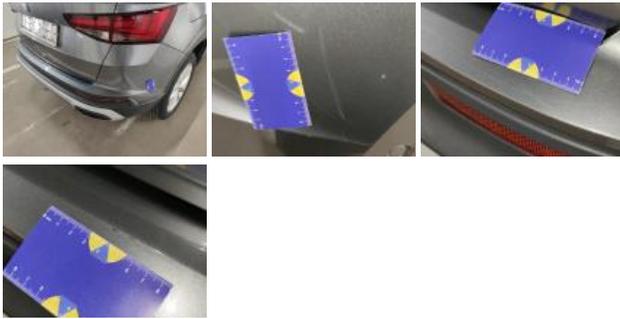
Bumper R, Scratch(es), Polish

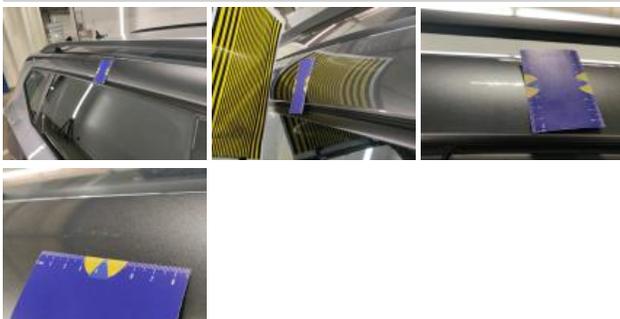
Roof pillar R, Dent(s), Acceptable
