**OPEL Astra Sports Tourer: 1YNL780**

**Limited Technical Inspection**

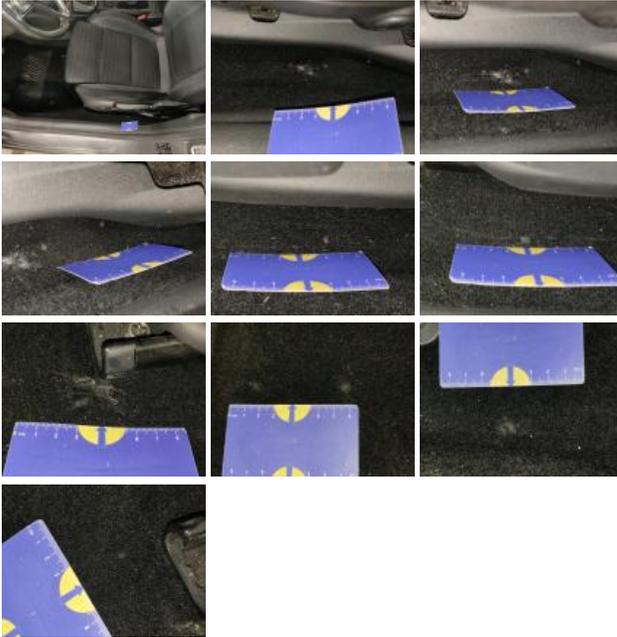
Floor covering FL, Burned, Smart repair

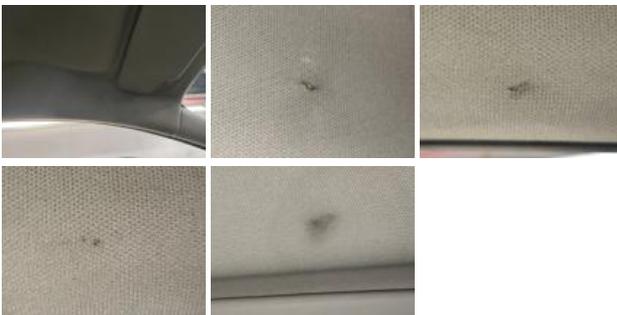
Roof liner, Hole, Smart repair

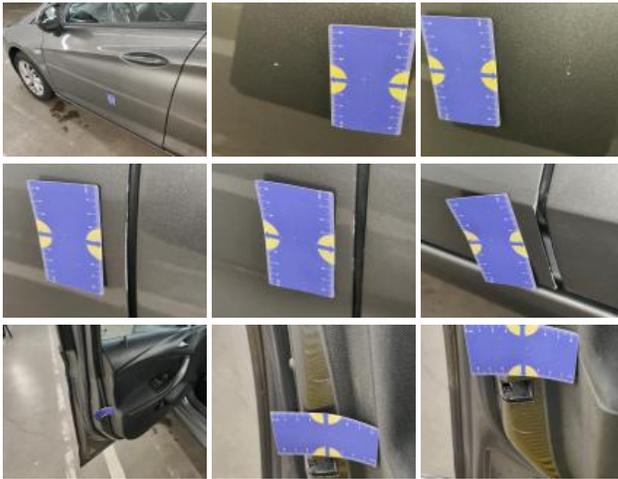
Door FL, Scratch(es), Spot repair

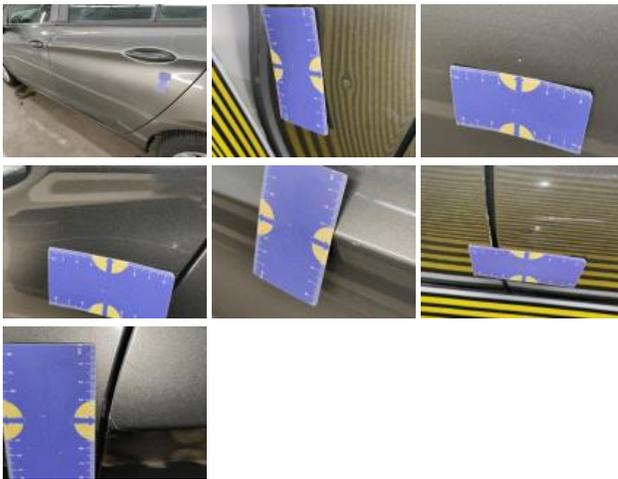
Door RL, Dent(s) and scratch(es), Spot repair

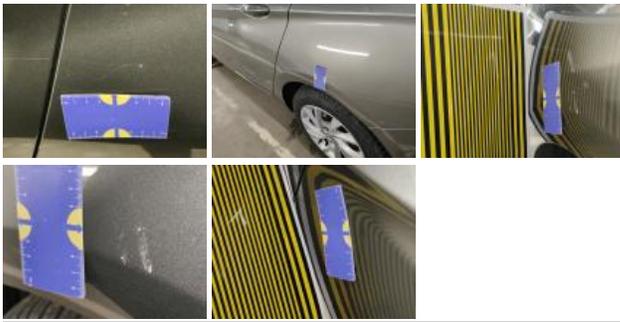
Wing RL, Dent(s), Spot repair

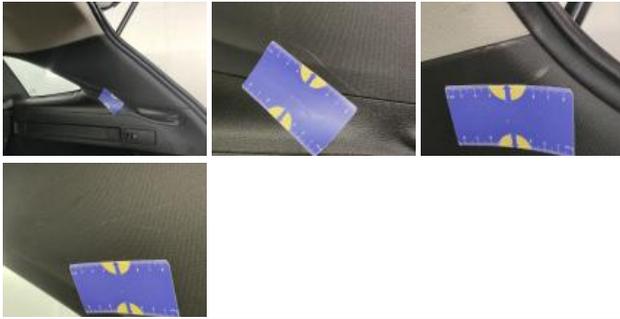
Internal boot lining R, Scratch(es), Smart repair

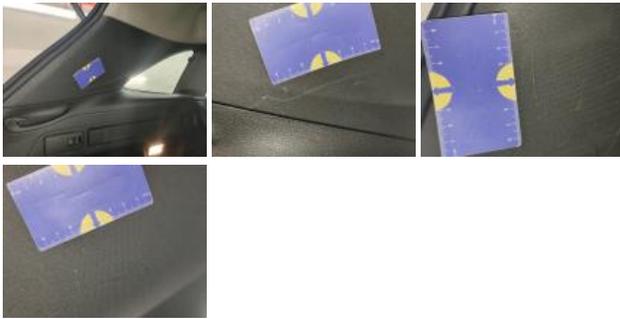
Internal boot lining L, Scratch(es), Smart repair

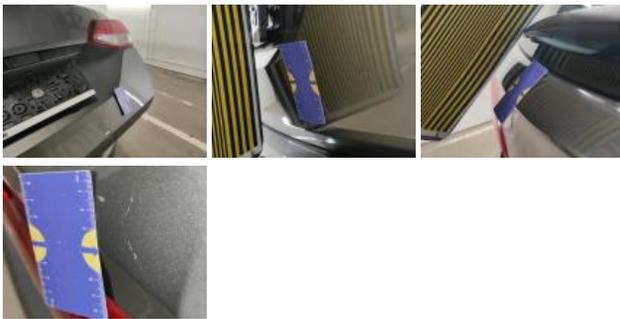
Tailgate / Boot, Dent(s), Acceptable

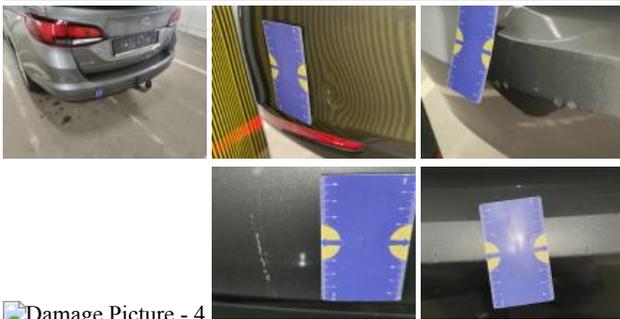
Bumper R, Dent(s) and scratch(es), Repair and paint (complete)
