VOLVO XC60: 2ABR053

Limited Technical Inspection

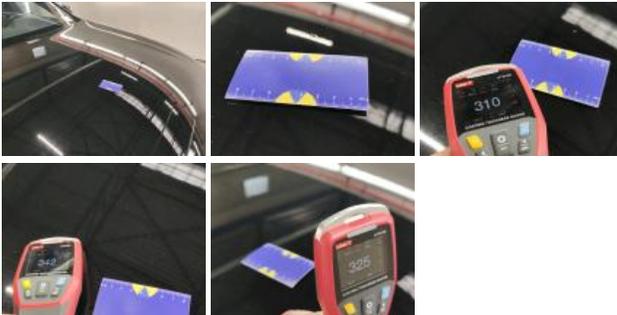
Bonnet, Bad repair, Repair and paint (complete)

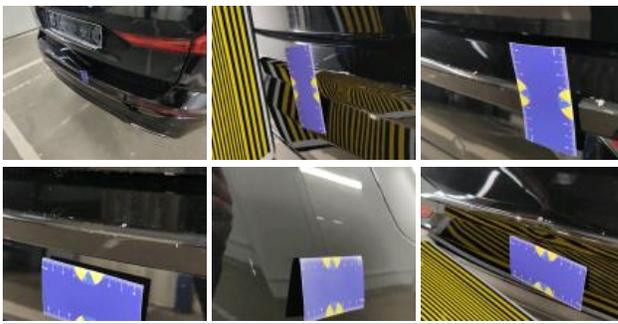
Bumper R, Dent(s) and scratch(es), Repair and paint (complete)

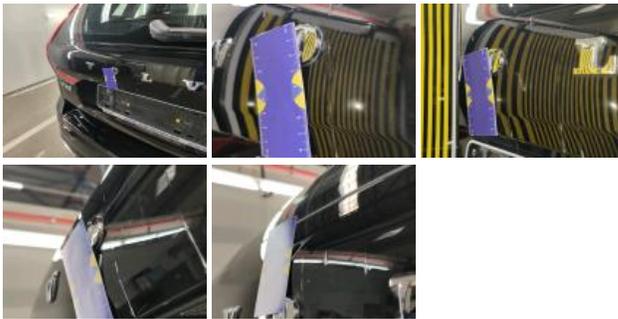
Tailgate / Boot, Bad repair, Repair and paint (complete)

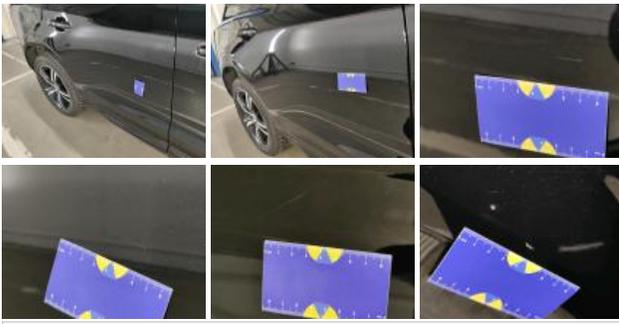
Door RR, Scratch(es), Polish

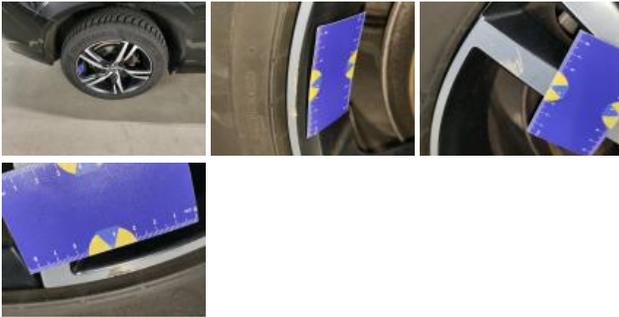
Alloy rim RR polished, Scratch(es), Acceptable
