| OPEL Corsa: 2CNK245 | | | |
| Vinnnumber: | VXKUPHNSSN4346487 | Versionname: | Corsa 1.2 Turbo S/S Auto GS Line 96kW/131pk |

| Limited Technical Inspection | | | |

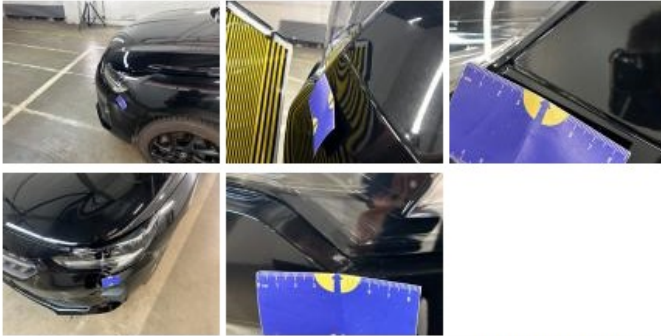
Bumper F, Bad repair, Spot repair

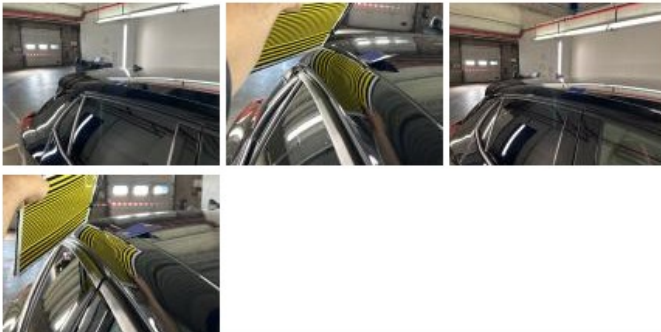
Roof pillar R, Bad repair, Spot repair

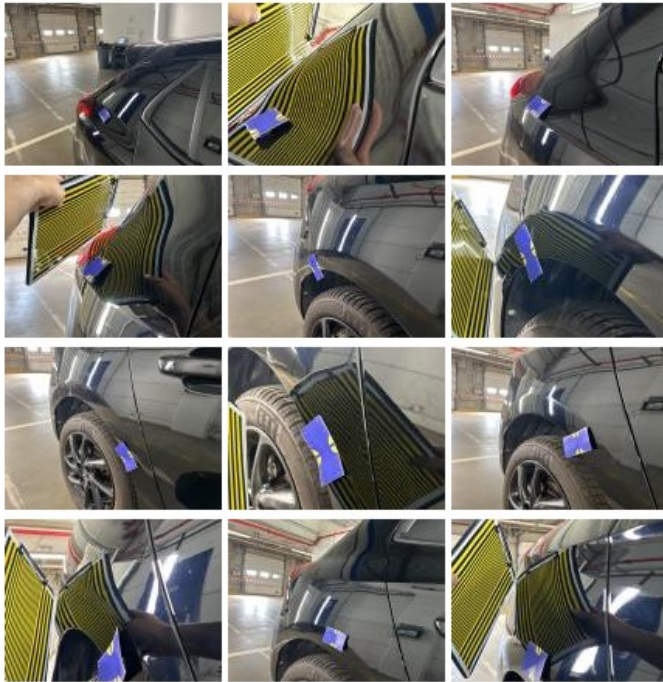
Wing RR, Bad repair, Spot repair

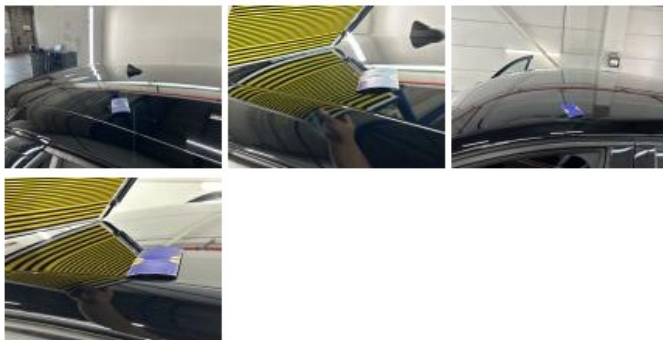
Roof, Dent(s), Paintless dent repair
