MERCEDES A-Klasse: 1YQN034

Vinnnumber:	W1K1770031V081341	Versionname:	A-Klasse A 180 d Business Solution 85kW/116pk 5D/P Auto-7
First Registrationdate:	5/11/2020	Fiscalpower:	
Expertise Mileage:	53216	Power Kw:	
Bodytype:		Body colour:	Black
Gearbox:	Automatic	Type of rims (mounted):	Aluminium
Transmission:	Front	Parking lot:	b506
Fueltype:	Diesel		
Number of doors:	5		
Number of seats:	5		
Number head rests:	5		
Type of rims (mounted):	Aluminium		
Certificate of Conformity:	Yes		
Category:	Passenger Car		
Registration Certificate Car (BE):	Yes		
Bodywork:	Clean		
Interior:	Dirty

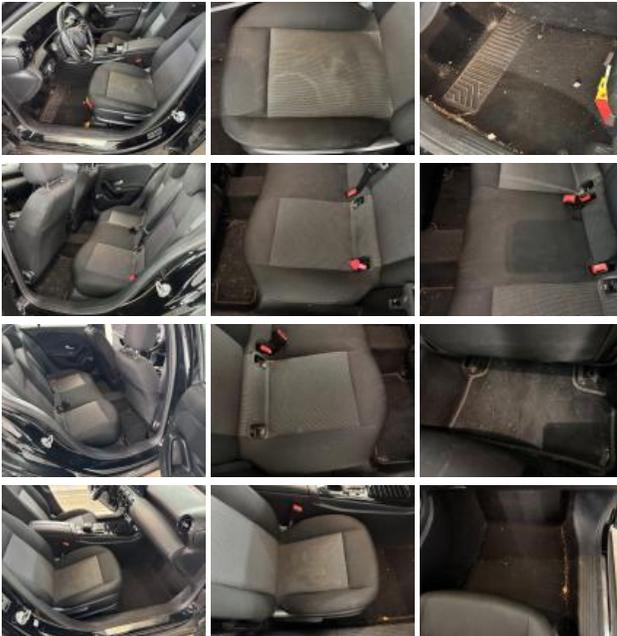
Interior, Dirty, Chemical cleaning

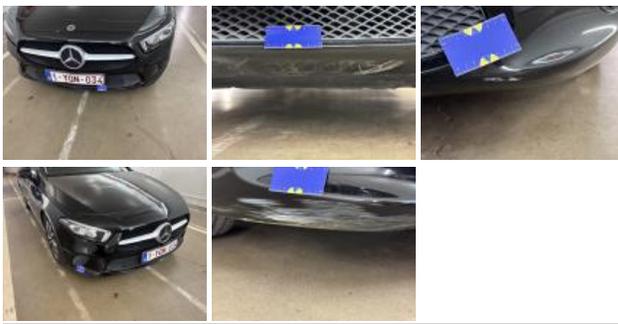
Bumper F, Scratch(es), Repair and paint (complete)

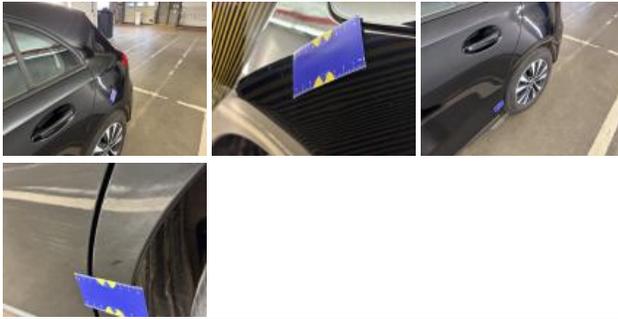
Wing RL, Scratch(es), Spot repair

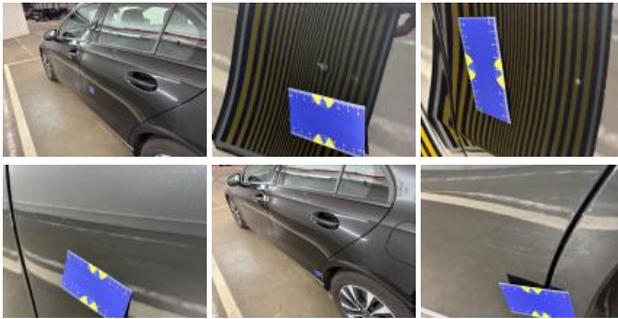
Door RL, Dent(s) and scratch(es), Repair and paint (complete)

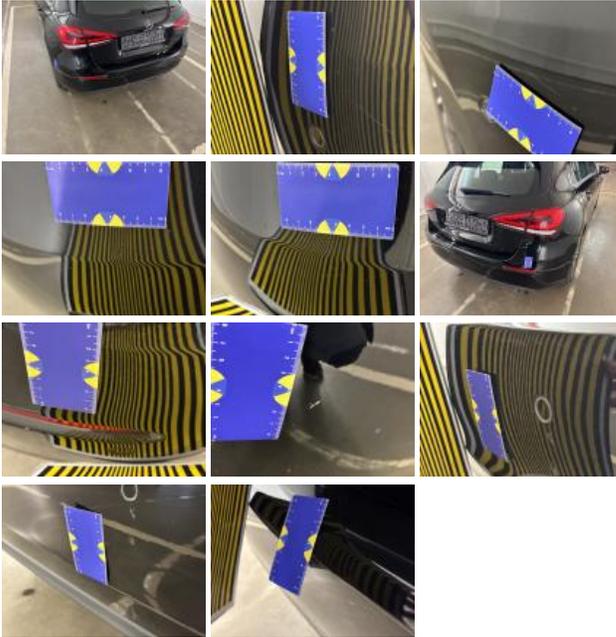
Bumper R, Bad repair, Repair and paint (complete)

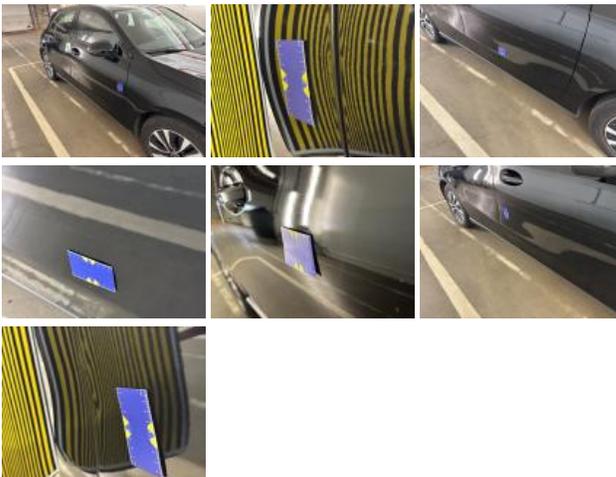
Door FR, Dent(s) and scratch(es), Repair and paint (complete)
