**MERCEDES A-Klasse: 1WWC475**

Vinnnumber:	<b>WDD1770031J157360</b>	Versionname:	<b>A-Klasse A 180 d Business Solution 85kW/116pk</b>
First Registrationdate:	<b>3/10/2019</b>	Fiscalpower:	<b>5D/P Auto-7</b>
Expertise Mileage:	<b>109990</b>	Power Kw:	
Bodytype:		Body colour:	<b>Grey</b>
Gearbox:	<b>Automatic</b>	Type of rims (mounted):	<b>Aluminium</b>
Transmission:	<b>Front</b>	Parking lot:	<b>b311</b>
Fueltype:	<b>Diesel</b>		
Number of doors:	<b>5</b>		
Number of seats:	<b>5</b>		
Number head rests:	<b>5</b>		
Type of rims (mounted):	<b>Aluminium</b>		
Certificate of Conformity:	<b>Yes</b>		
Category:	<b>Passenger Car</b>		
Registration Certificate Car (BE):	<b>Yes</b>		
Bodywork:	<b>Clean</b>		
Interior:	<b>Clean</b>

**Limited Technical Inspection**

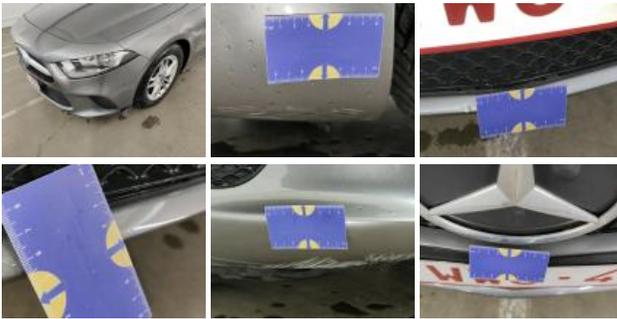
Bumper F, Scratch(es), Spot repair

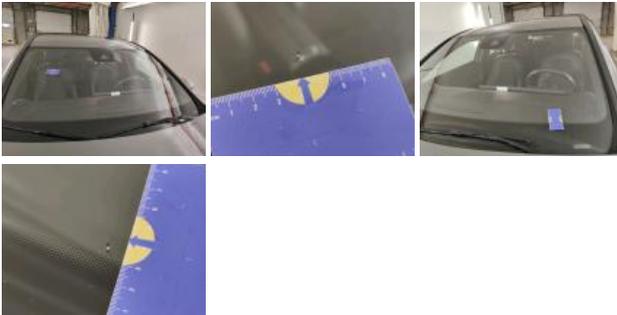
Windscreen, Stone chip(s), Windscreen repair

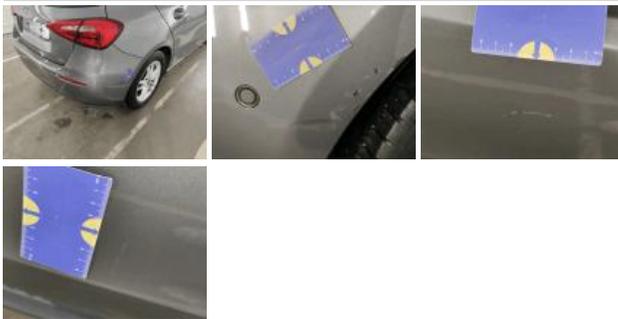
Bumper R, Scratch(es), Spot repair
